Technical Report No. 88.216.18.091.01 part 2 of 2

Client: Boson Robotics Ltd

Test subject: Product: Mono Crystalline Silicon Photovoltaic (PV) Modules
Type: DS-M250(96)

- According to the visual inspection test, EL test and IV character under outdoor condition of PV module, find the Influence of cleaning robot operation on photovoltaic modules

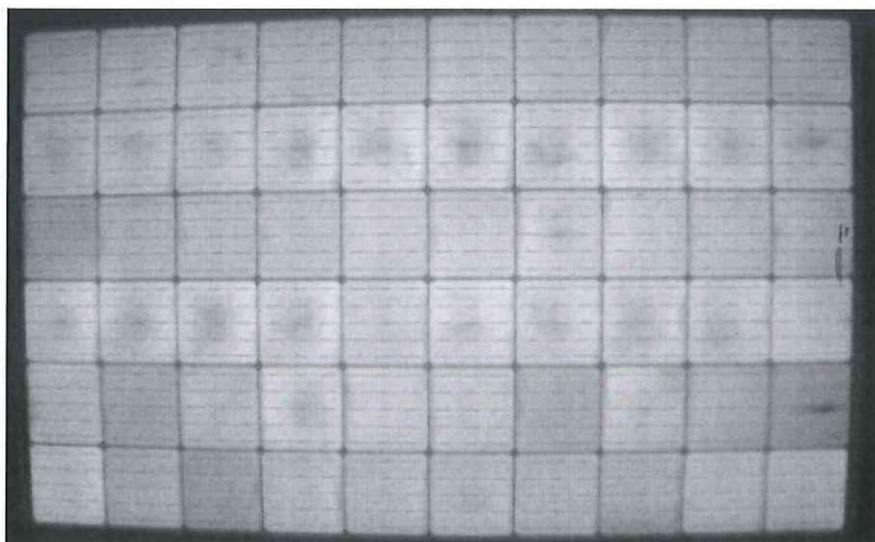
Before cleaning of CAAL216000189D

No.	Serial number	Before/ after cleaning	crack or not?
1	CAAL216000189D	Before	No crack
		After	No crack
2	CAAL216011616	Before	No crack
		After	No crack
3	CAAC217007891	Before	No crack
		After	No crack
4	CAAC217007948	Before	No crack
		After	No crack
5	CAAL216000465D	Before	No crack
		After	No crack
