Technical Report No. 88.216.18.091.01 part 2 of 2

Client: Boson Robotics Ltd

Test subject: Product: Mono Crystalline Silicon Photovoltaic (PV) Modules
Type: DS-M250(96)

- According to the visual inspection test, EL test and IV character under outdoor condition of PV module, find the Influence of cleaning robot operation on photovoltaic modules

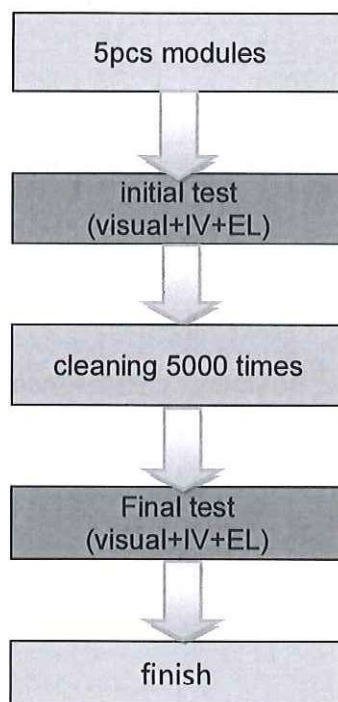
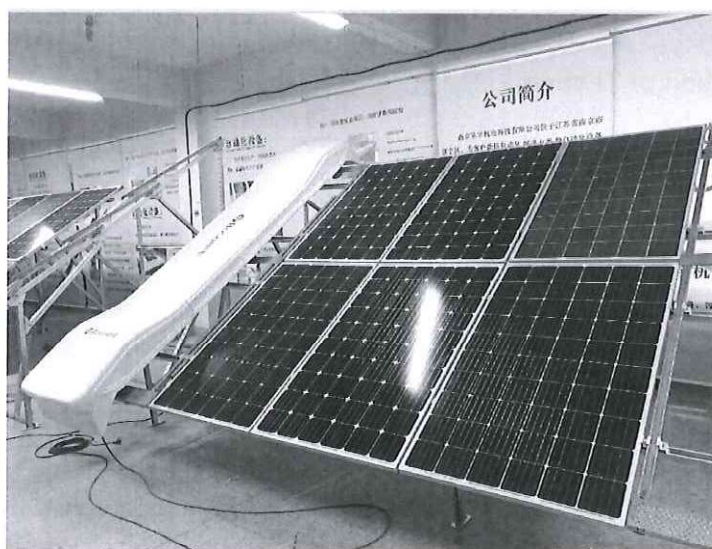
After installing (as below photo), do the Visual inspection, IV and EL test before and after 5000 times cleaning. Comparing the test data before and after cleaning, to confirm whether cleaning 5000 times has adverse effects on PV module.

Remark: cleaning from left to right is one time, from right to left is second times, the cleaning is automatic, after cleaning do visual inspection, IV and EL test. Visual inspection is done under 1000Lux.

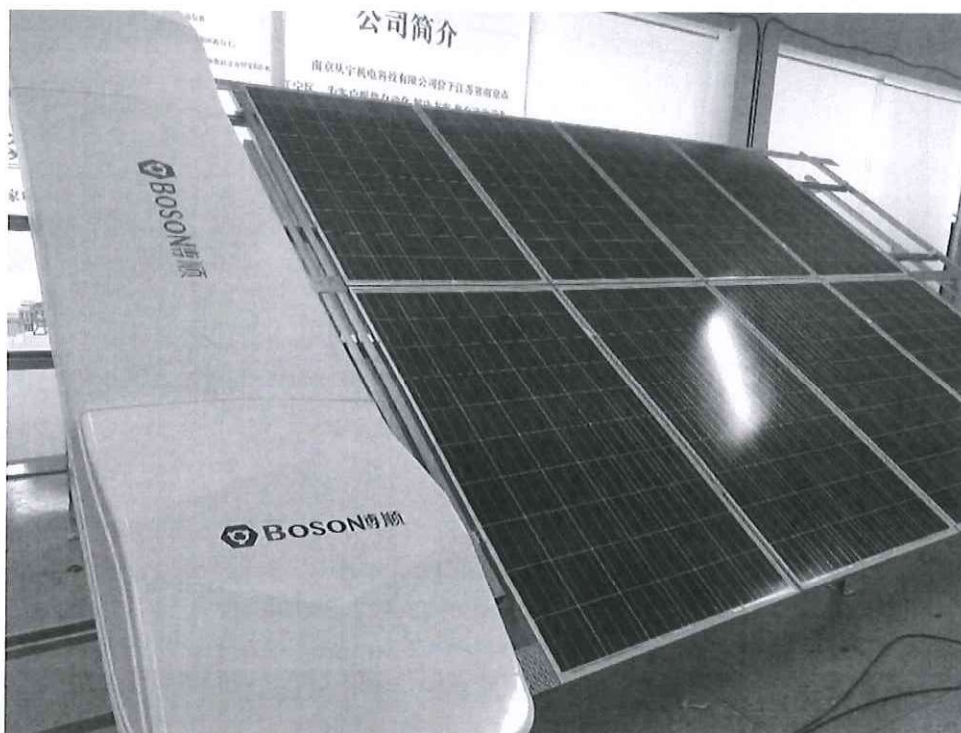
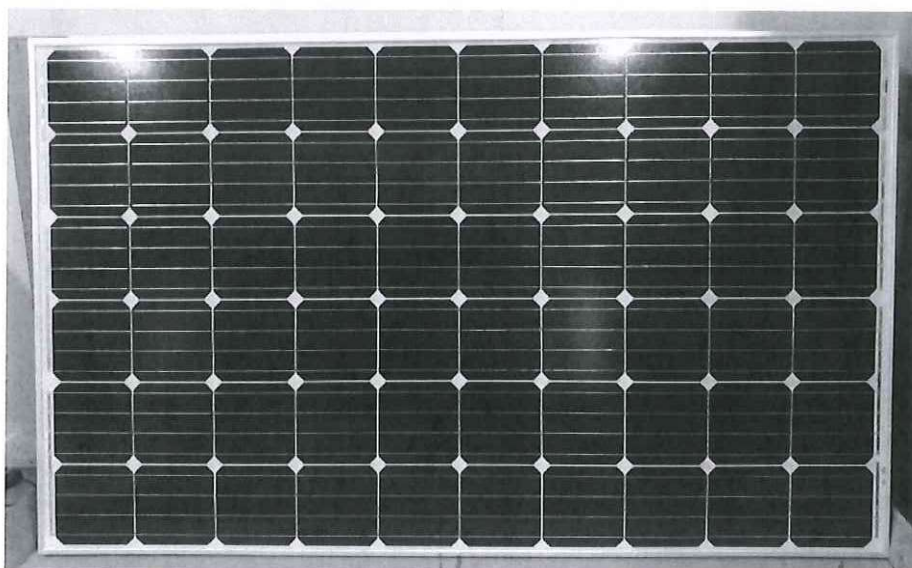
3.4 Picture of test site and test sample

Using the cleaning equipment to clean 5 pcs modules, do the test before and after 5000 times cleaning (Visual, IV, EL), comparing the test data before and after cleaning, there is no visual defects, no adding new cracks, IV parameter is also OK.
